# **Release Notes for SANtricity ES Storage Manager 10.86 for E-Series Storage Systems and the EF540 Flash Array**

Part number: 215-07663\_C0  
May, 2014

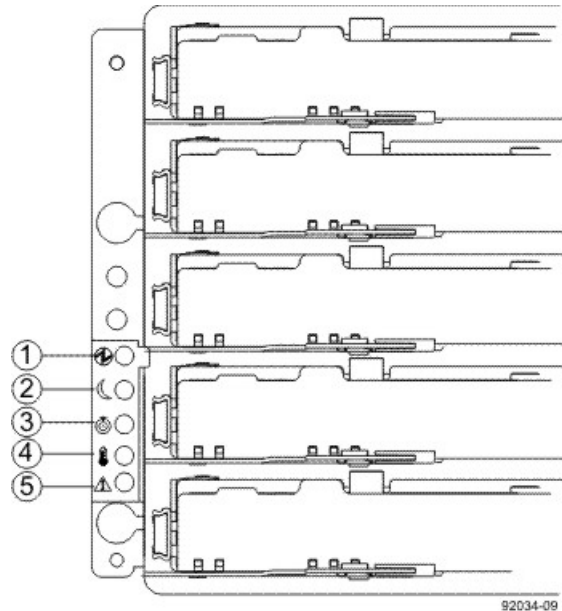
**Figure 1 LEDs on the Left Bezel**

The following topics provide details on the LEDs found on the E5560 controller-drive tray.

**Table 1 LEDs on the Left Bezel**

| Location | LED | Color | On | Off |
|---|---|---|---|---|
| 4 | Controller-drive tray Over-Temperature | Amber | The temperature of the controller-drive tray has reached an unsafe level. | Normal status. |

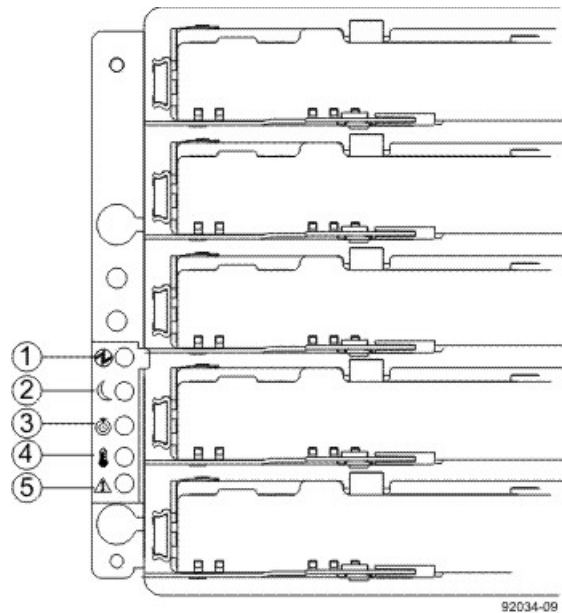
Figure 5 LEDs on the Left Bezel

Table 5 LEDs on the Left Bezel

| Location | LED | Color | On | Off |
|---|---|---|---|---|
| 4 | Drive Tray Over-Temperature | Amber | The temperature of the drive tray has reached an unsafe level. | Normal status. |

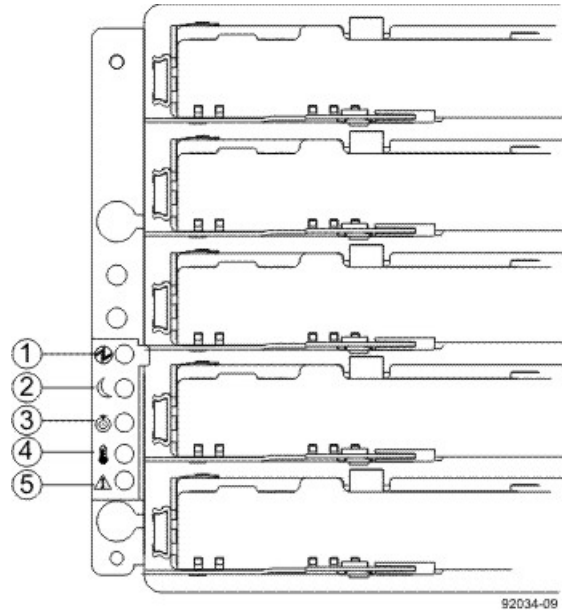
Figure 6 LEDs on the Left Bezel

Table 6 LEDs on the Left Bezel

| Location | LED | Color | On | Off |
|---|---|---|---|---|
| 4 | Drive Tray Over-Temperature | Amber | The temperature of the drive tray has reached an unsafe level. | Normal status. |
